MARYLAND HISTORICAL TRUST WORKSHEET

NOMINATION FORM

Maryland HISTORIC AMERICAN BUILDINGS SURVEY 1. STATE INVENTORY CE-155 COUNTY Cecil VICINITY TOWN Elkton 2. NAME 217 East Main Street STREET NO. 217 East Main St. DATE OR PERIOD 1850 - 1860 ORIGINAL OWNER STYLE classic ORIGINAL USE dwelling ARCHITECT PRESENT OWNER Elkton Methodist Church BUILDER FRESENT USE Church House WALL CONSTRUCTION

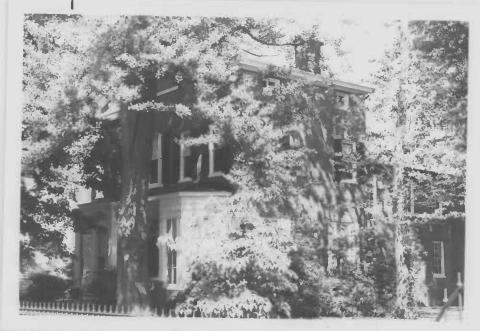
Rubenstone house Elkton 188 6/13

217 E. Main St is a five bay long brick b uilding with pediment gable facade facing the street. It is two bays deep and has a long two story brick wing out the rear of the building. The brick is laid in all stretcher bond and the brick of the facade is smoother than the remainder of the structure. There are flat arches above the windows except the middle second floor window which consists it three parts and has segmental arch above. All second floor windows have 1/1 sash and louvered shutters.

First floor tacade consists of a central door naving semicircular fanlight. like Essex Lodge near Earleville, flanked by pilasters which support the roof of the entrance porch, and two three-part bay windows. The roof of the porch connects the roof of the pay wingw. On each side of the steps to the porch is a same squat balustrade and two square columns of the same design as the pilasters.

Eyenrow windows in the attic are visible on each side of the chimney on the east and west sides of the main structure.
